# FINAL REPORT FOR REMEDIATION OF LOCATIONS IN GRANITE CITY, MADISON, AND VENICE, ILLINOIS, ASSOCIATED WITH NL INDUSTRIES/TARACORP SUPERFUND SITE

# PRE-PLACED CONTRACT NO. DACW45-89-D-0506 DELIVERY ORDER NO. 0017

November 22, 1996 Project 16473

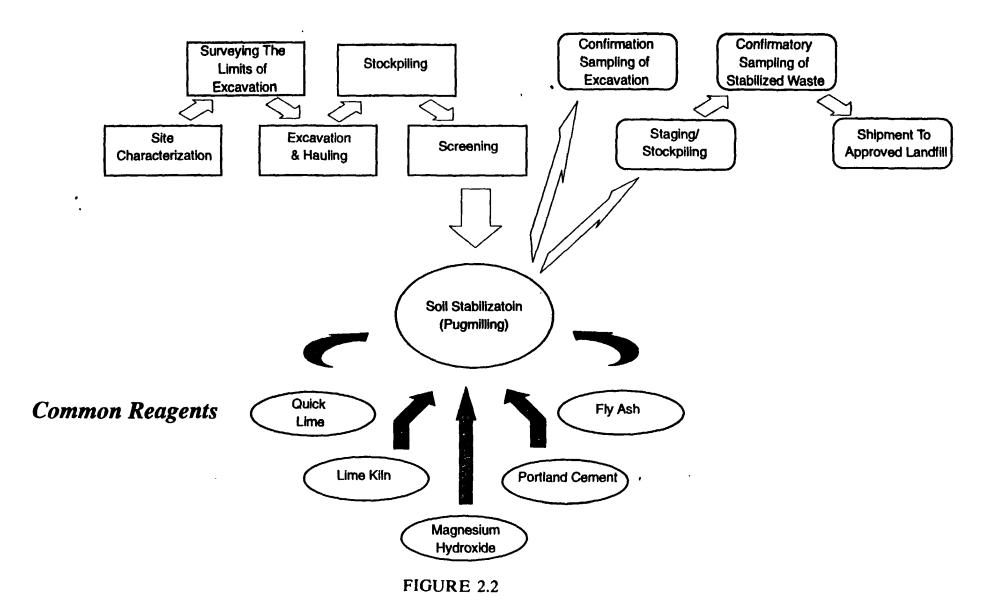
## Stabilization Preparation

## Stabilized Waste Placement

STABILIZATION METHODOLOGY

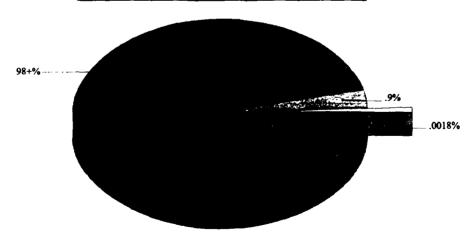
Note: 0% was above action level

# **PERSONNEL**

Above Action Level
Above Detection Limit
Below Detection Limit

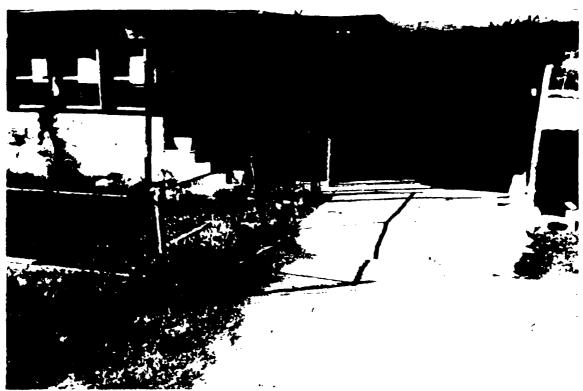
1. View of residential property prior to excavation.

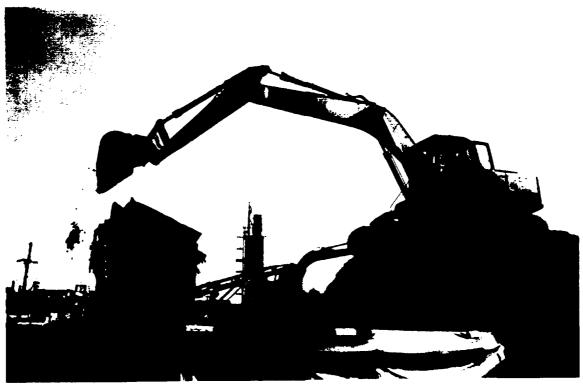
6. View of hazardous soil being fed into power screen.

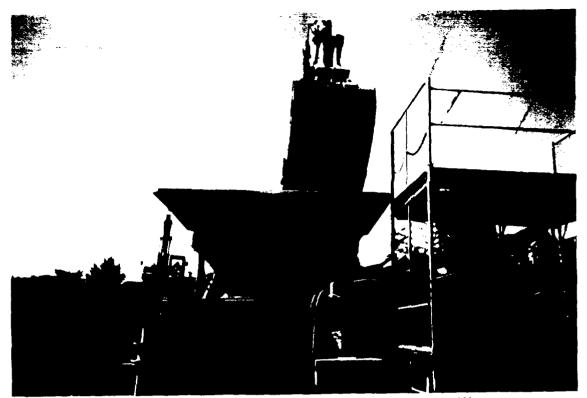
7. View of screened hazardous soil being fed into pugmill.

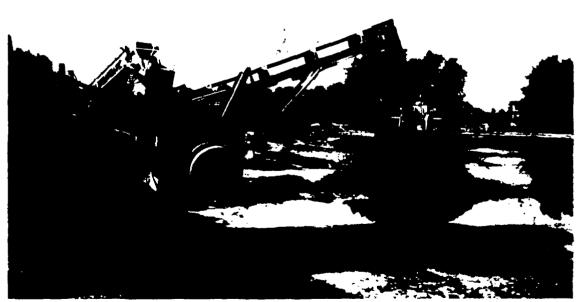
8. View of treated soil to be stockpiled into 100-ton piles.

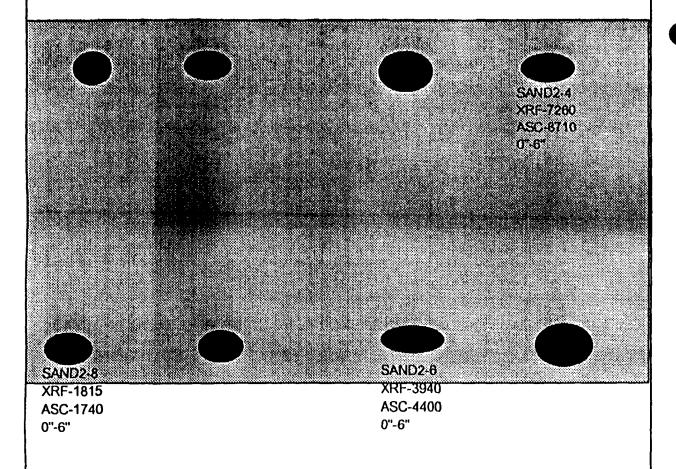
SAND ROAD #2

SAMPLE POINTS WITH RESULTS ABOVE 1500 PPM.
